Hamilton Beach 25460Z Top Heating Element Solders Replacement

Use this guide to replace damaged solder joint(s) that can be preventing your Panini Press from heating up.

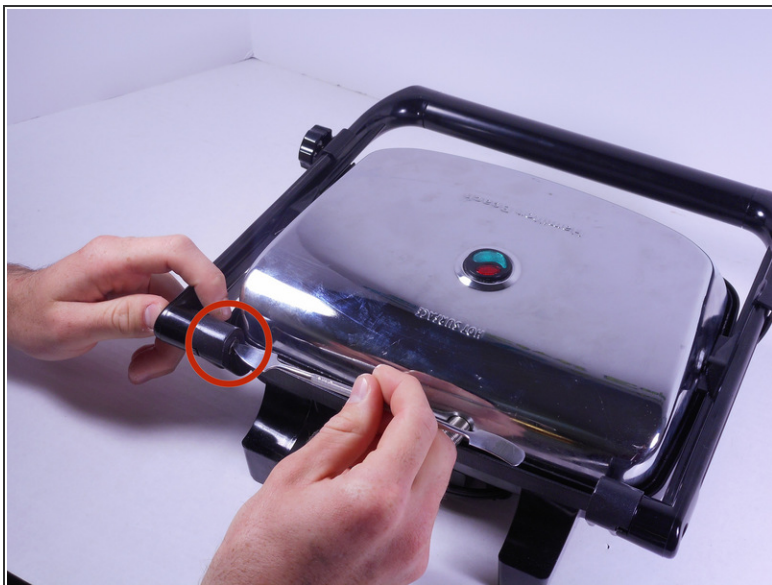
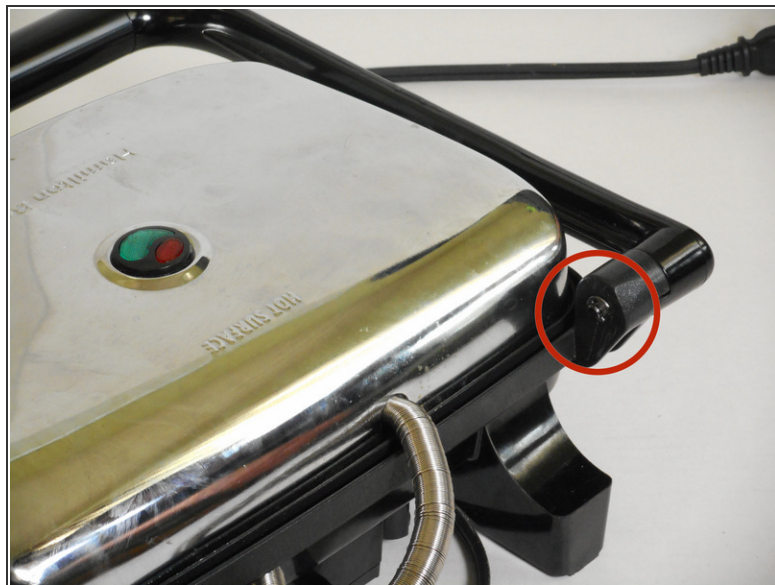
Step 1 — Handle

- On the back of the press, remove the locking washer by prying upwards with the nylon or metal spudger tool.
- Repeat for the other washer across from the first one.

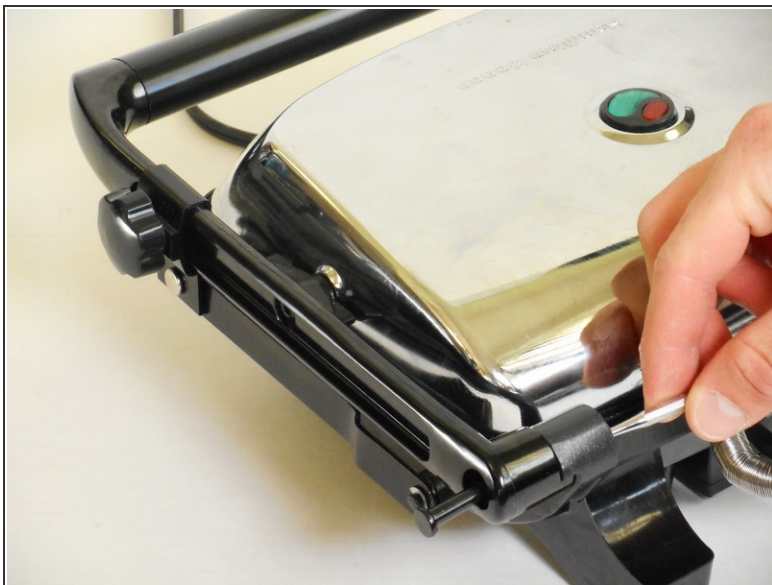
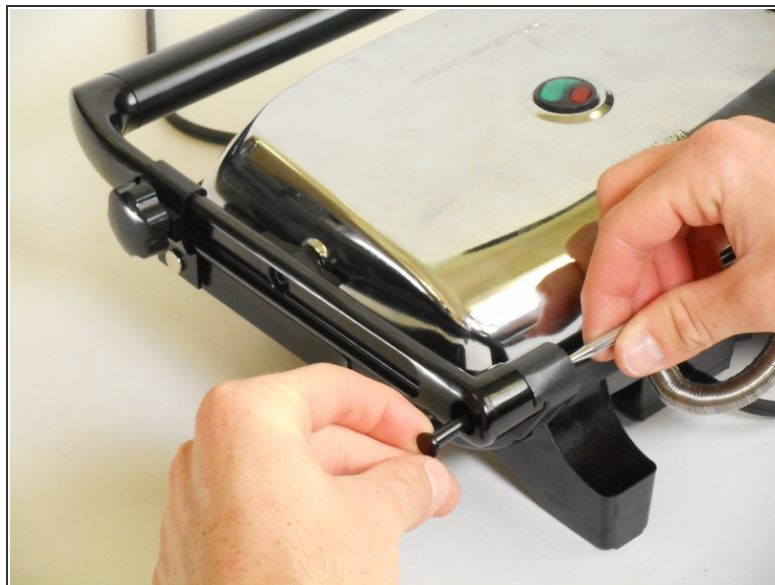
Step 2

- Using any long, thin object, push the 43mm bolt from the inside towards the outside to expose the end of the bolt.
- Pull the end of the bolt out to completely remove it.
- Repeat for the second bolt.

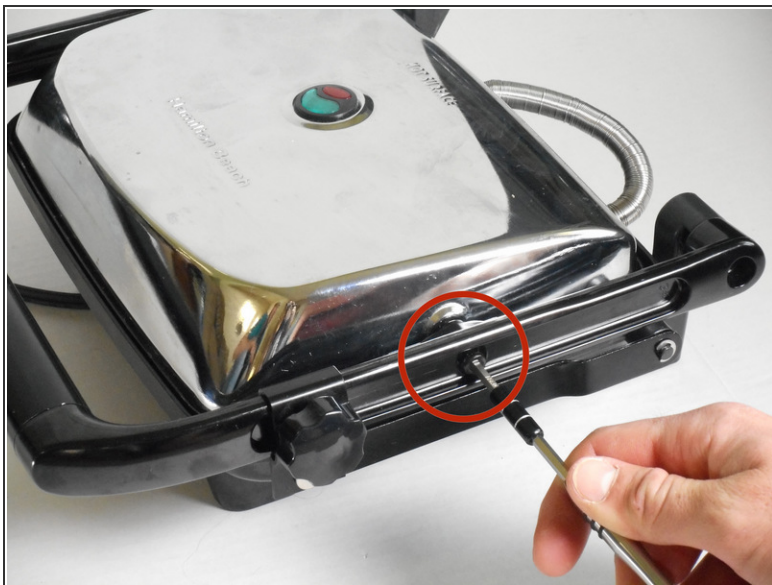
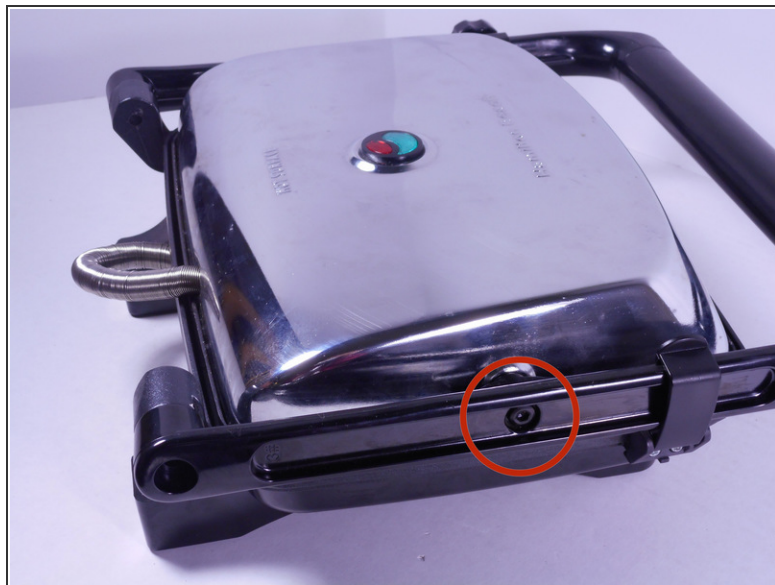
Step 3

- Using the 4.0mm Allen Wrench, unscrew the two 26mm bolts connecting the handle to the upper heating element housing on both sides.

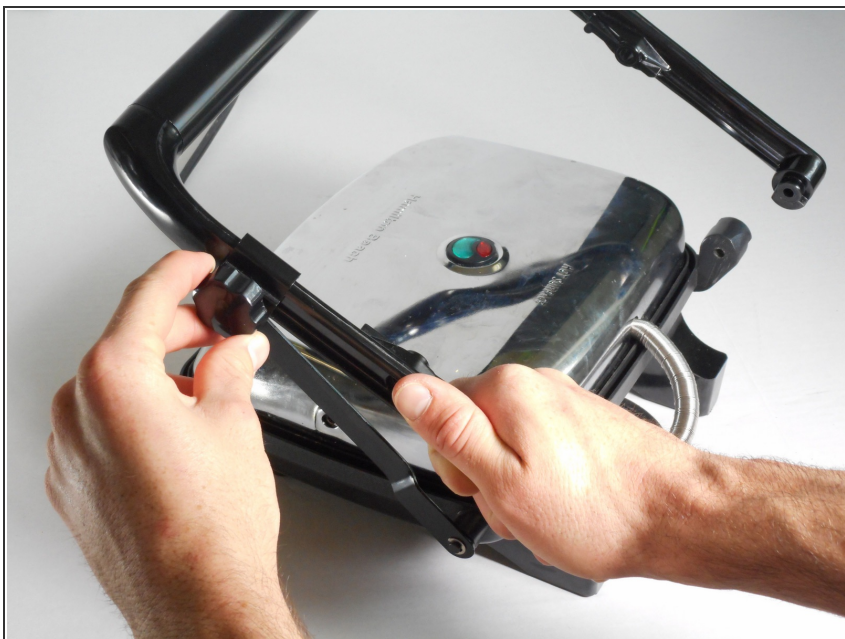
Step 4

- Unscrew the locking knob all the way to remove it.

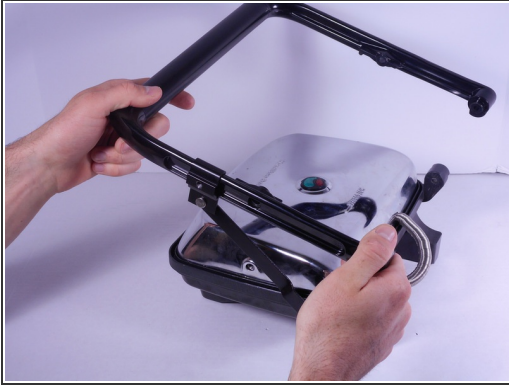
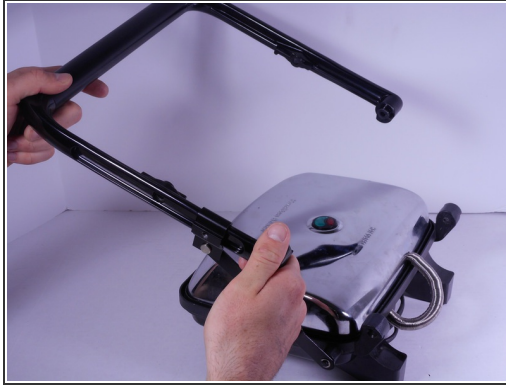
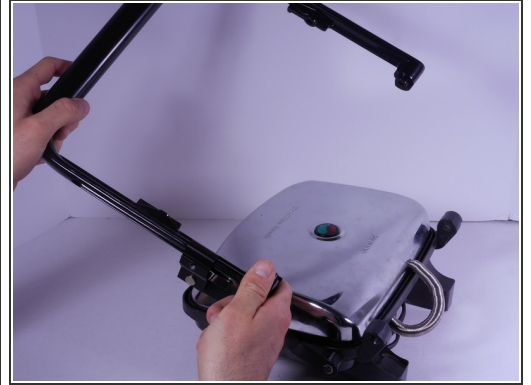
Step 5

- Slide the locking knob couple down to the base of the handle, then pull up on the free end of the handle. It will easily pop off.

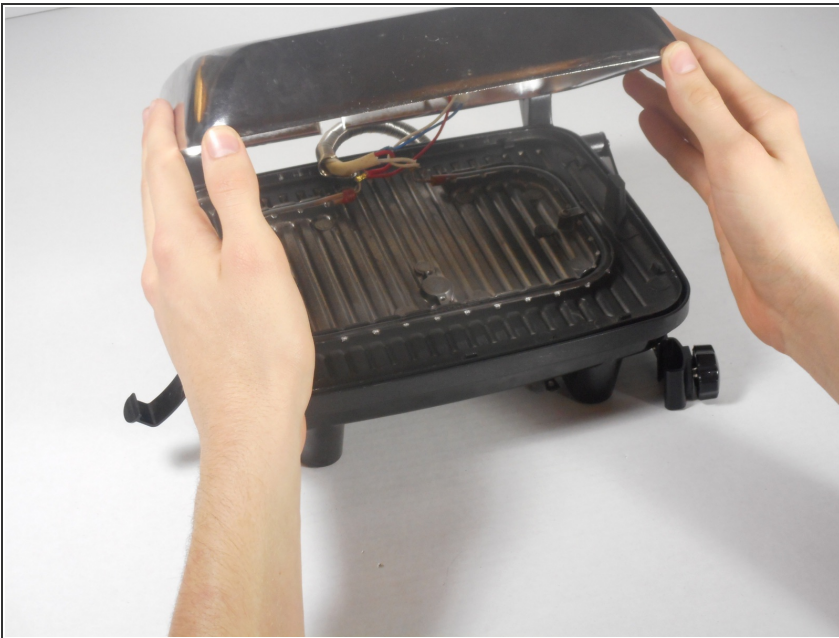
Step 6 — Top Heating Element Solders

- Gently separate the heating element housing from the cooking surface by pulling up on the housing and pushing down on the surface.

Pulling too far or too hard can break the delicate internal wiring.

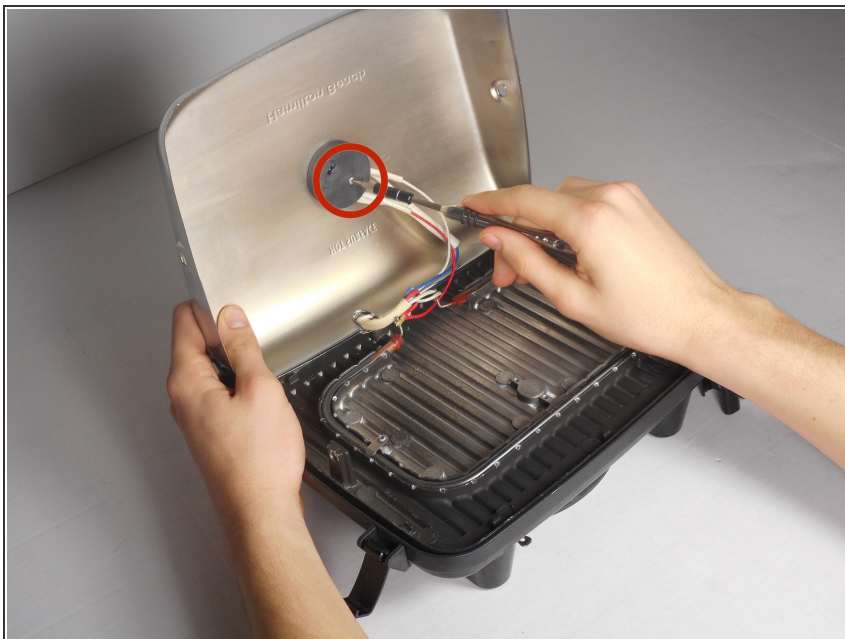
Step 7

- On the underside of the housing, use the PH2 Screwdriver to remove the single 12mm screw to disconnect the LED tray.
- The housing can now be completely removed.
